NIST NCSTAR 1-5A

**Federal Building and Fire Safety Investigation of
the World Trade Center Disaster**

Visual Evidence, Damage Estimates, And Timeline Analysis

William M. Pitts
Kathryn M. Butler
Valentine Junker

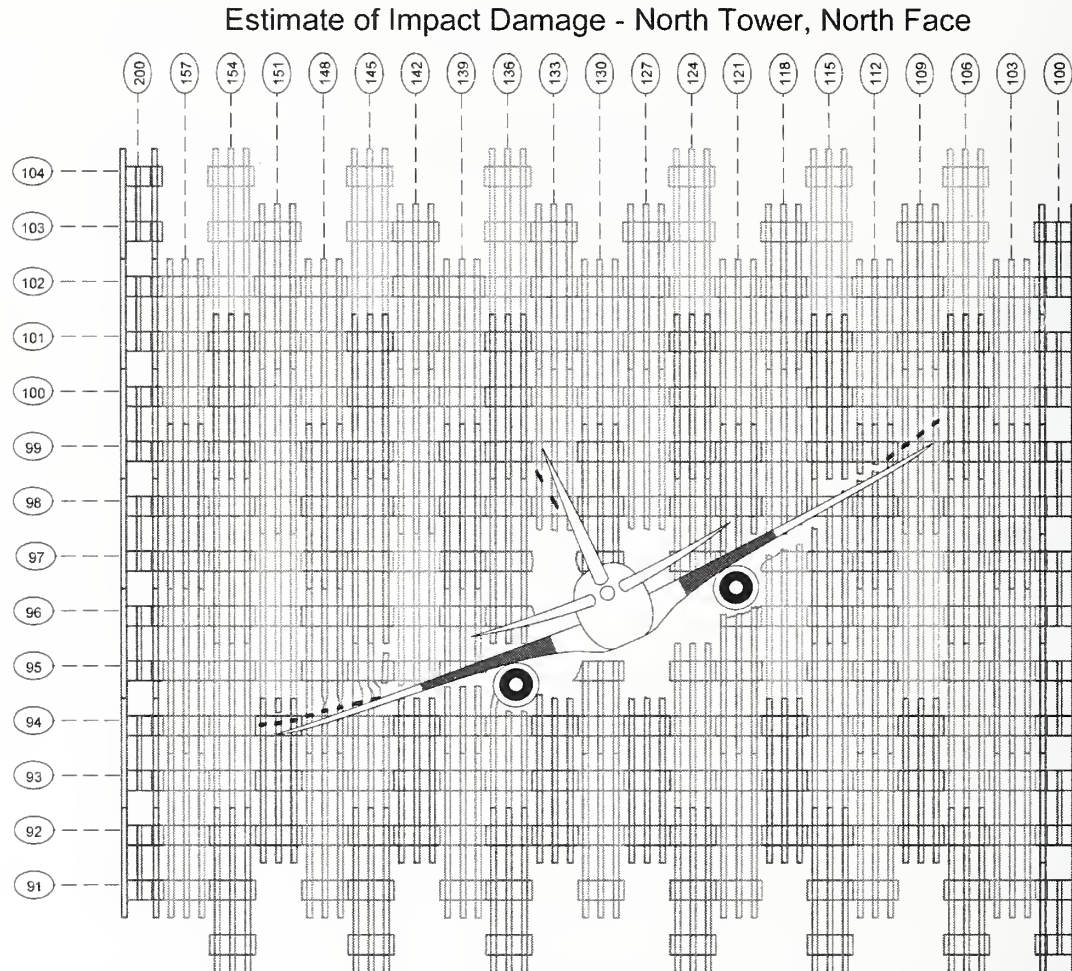
Close-up photographs and videos showing the area of the aircraft impact on the north face were used to generate the damage diagram shown in Figure E-1. Images show that substantial areas of the concrete floor slabs for the 95th through 97th floors were destroyed to an unknown depth within the tower in the immediate vicinity of the aircraft impact area. Locations where the two wing tips and the aircraft’s vertical stabilizer struck the façade are represented by dashed lines in Figure E-1. The locations of the wing marks indicate that the aircraft struck between the 93rd and 99th floors. A properly scaled outline of a Boeing 767-200ER is superimposed on the damage diagram. The position of the aircraft has been adjusted to provide good agreement with the observed damage pattern and the wing and vertical stabilizer marks. The drawing indicates that the nose of the aircraft struck close to the center of the face near columns 129 and 130 at a height that was near the concrete floor slab for the 96th floor.

Figure E-1. A scaled outline of a Boeing 767-200ER is superimposed on the damage diagram for the north face of WTC 1. The position of the aircraft has been adjusted to best match the damage pattern and marks showing where the wing tips and vertical stabilizer struck. The red areas correspond to the approximate locations of fuel on the aircraft based on an analysis reported elsewhere (NIST NCSTAR 1-2B).

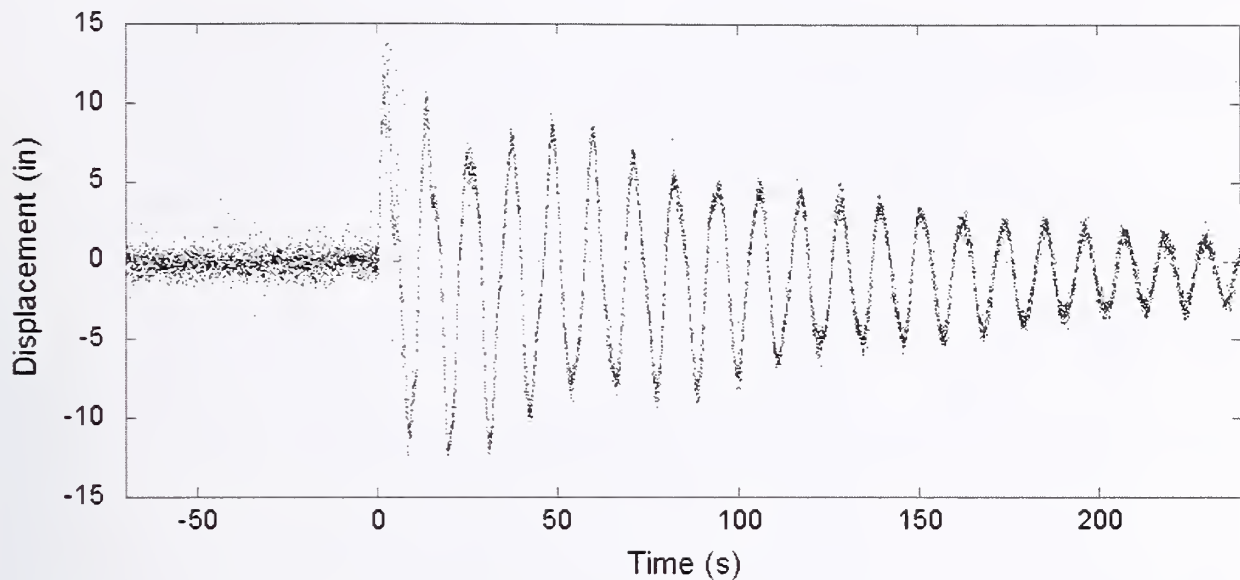
Close examination of this video revealed a perceptible north-south movement of WTC 2 after it was struck by the aircraft. Image analysis of the video allowed the movement of the tower at the 70th floor to be determined as shown in Figure E-2. The maximum deflection was determined to be $12 \text{ in.} \pm 1 \text{ in.}$ at this height, which extrapolates to a value of $22 \text{ in.} \pm 5 \text{ in.}$ at the roofline. The primary period for the motion was $11.4 \text{ s} \pm 0.1 \text{ s}$, consistent with the fundamental natural mode of the building. Similar measurements using a brief video shot from the north yielded an amplitude near the roof line of $6 \text{ in.} \pm 1 \text{ in.}$ for the east-west direction with a period of $5.3 \text{ s} \pm 0.1 \text{ s}$. This period and motion are consistent with the first torsional (twisting) mode of the tower.

Figure E-2. The displacement of the first (left-most) window line on the 70th floor of WTC 2 determined using moiré analysis is shown as a function of time.

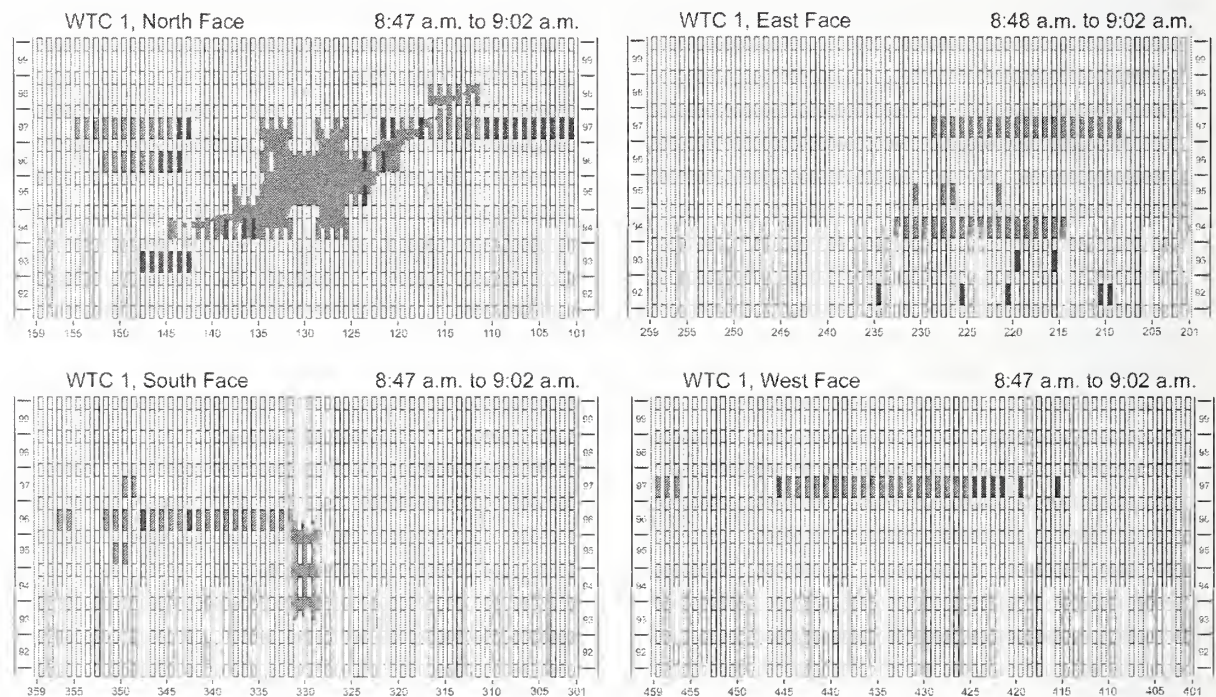
Fire observations for the period are summarized by the façade maps in Figure E-4, which show fire locations integrated over the period. The color coding indicates the highest fire intensity recorded during the period, with yellow representing a spot fire, red a more extensive fire burning inside the tower, and orange a fire with flames extending out of the window.

Figure E-4. Maps of integrated fire observations between 8:47 a.m. and 9:03 a.m. are shown for the four faces of WTC 1.

The most extensive fire growth took place on the 97th floor. The apparent rapid development of these fires, particularly on the west face, may be an indication that the fire growth and spread was accelerated by the presence of initially unburned aviation fuel that may have been dispersed over this floor during the aircraft impact.

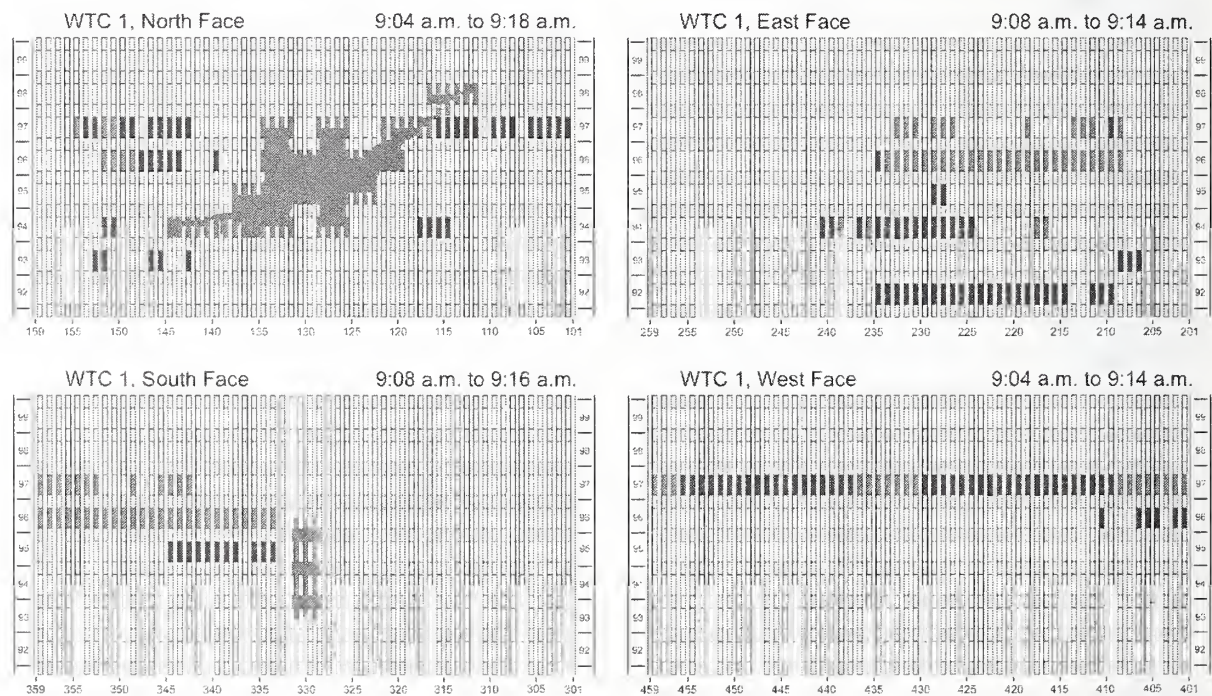
Figure E-5 shows integrated fire maps for the four faces of WTC 1 covering the period. Comparison with Figure E-4 reveals the changes in fire distributions between the two time periods. The most prominent feature in Figure E-5 is the extent of the fires on the 97th floor, with flames visible in a nearly continuous band running clockwise from just west of the center of the south face, along the western and northern faces, and reaching just past the center of the east face. Another feature which stands out is the general lack of visible fire in the southwest quadrant of the tower.

Figure E-5. Maps of integrated fire observations between 9:03 a.m. and 9:18 a.m. are shown for the four faces of WTC 1.

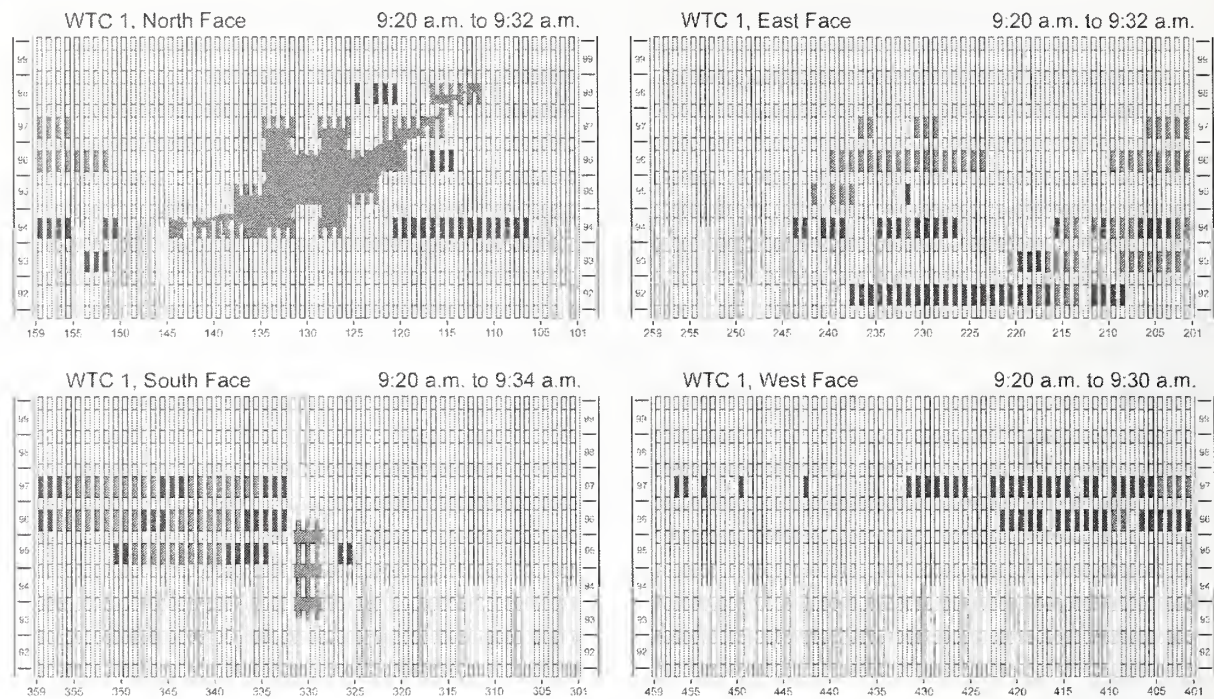
Integrated façade maps for the fires observed during the period are shown in Figure E-6. In general, fire spread during this period was reduced compared to the first two periods. While intensely burning fires with extended flames developed in northeast corner rooms on several floors, most of the new fire growth involved less intense flames that did not extend from windows. Such fires included those on the west side of the 94th floor and the central section of the 98th floor on the north face and the south side of the 96th floor on the west face.

Figure E-6. Maps of integrated fire observations between 9:19 a.m. and 9:35 a.m. are shown for the four faces of WTC 1.

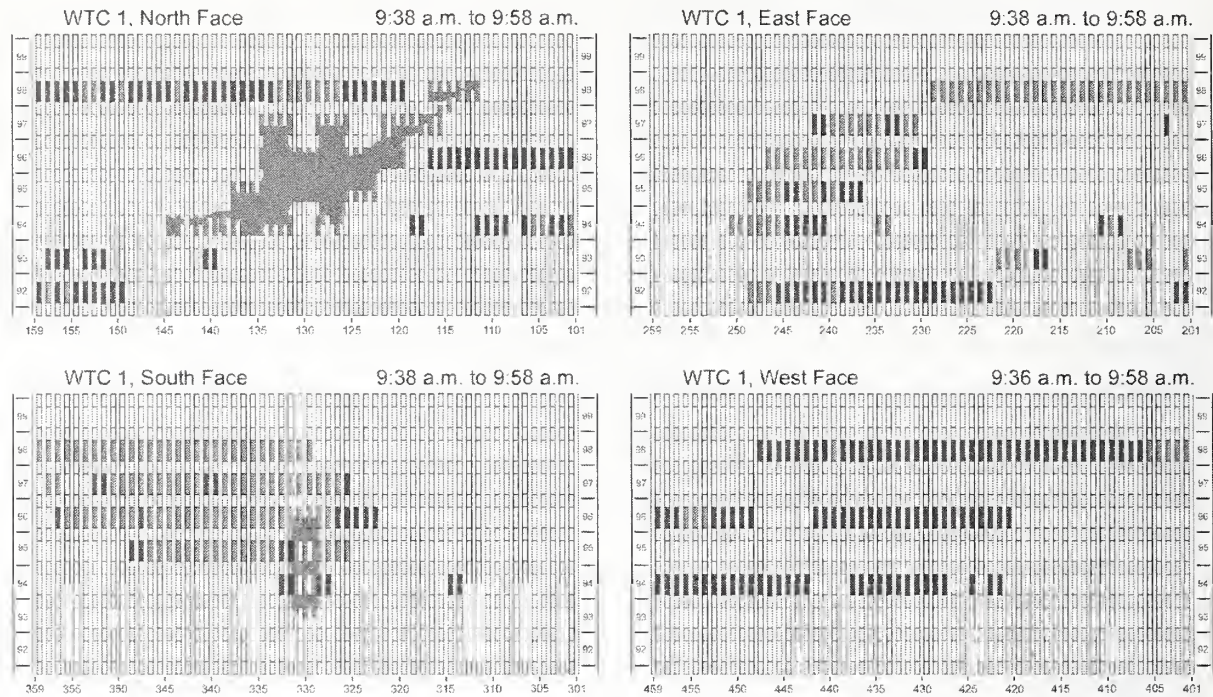
Figure E-7. Maps of integrated fire observations between 9:36 a.m. and 9:59 a.m. are shown for the four faces of WTC 1.

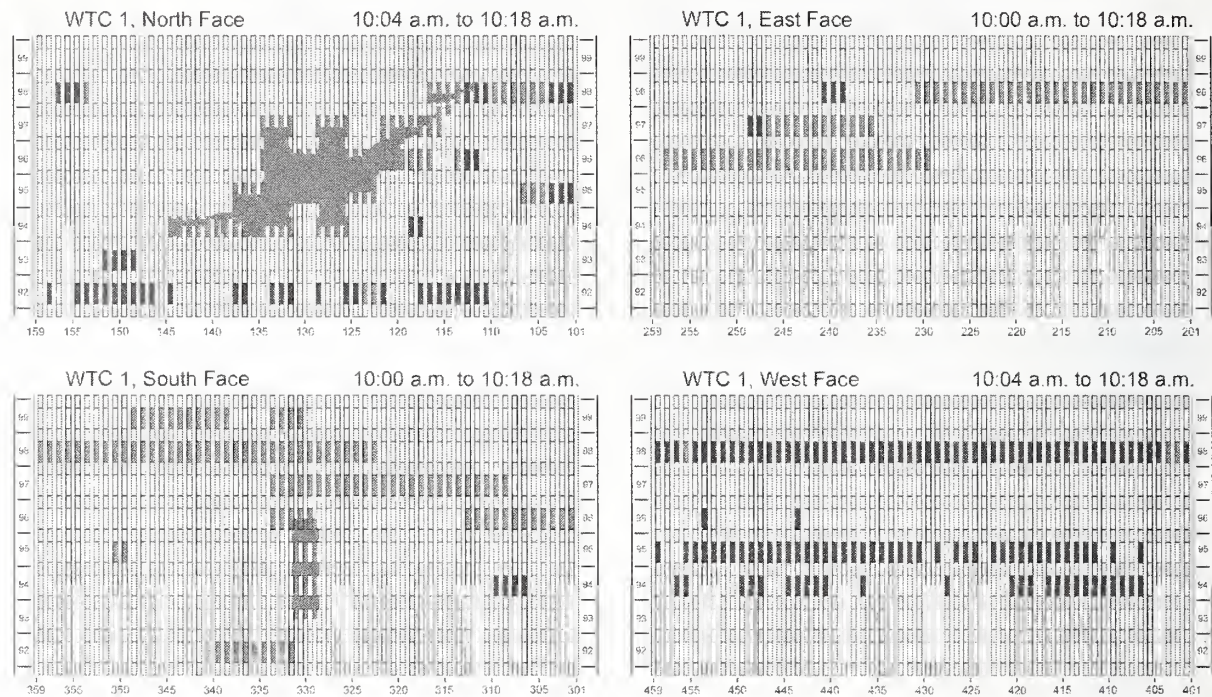
Integrated fire maps of the four faces for the period are included in Figure E-8. These maps likely underestimate the actual extent of the fires due to the limited visibility on the east and south faces. The extensive fires on the 98th floor are a dominant feature. Keep in mind that the much of the fire on the north side of this floor had already died down. The intense fires that developed rapidly along the periphery of the southeast quadrant also stand out. The broad extent of the low intensity fires on the west

sides of the 94th and 95th floors is also evident. Note that the intense fire that grew on the south side of the west face of the 104th floor is not displayed in the façade map.

Figure E-8. Maps of integrated fire observations between 10:00 a.m. and 10:18 a.m. are shown for the four faces of WTC 1.

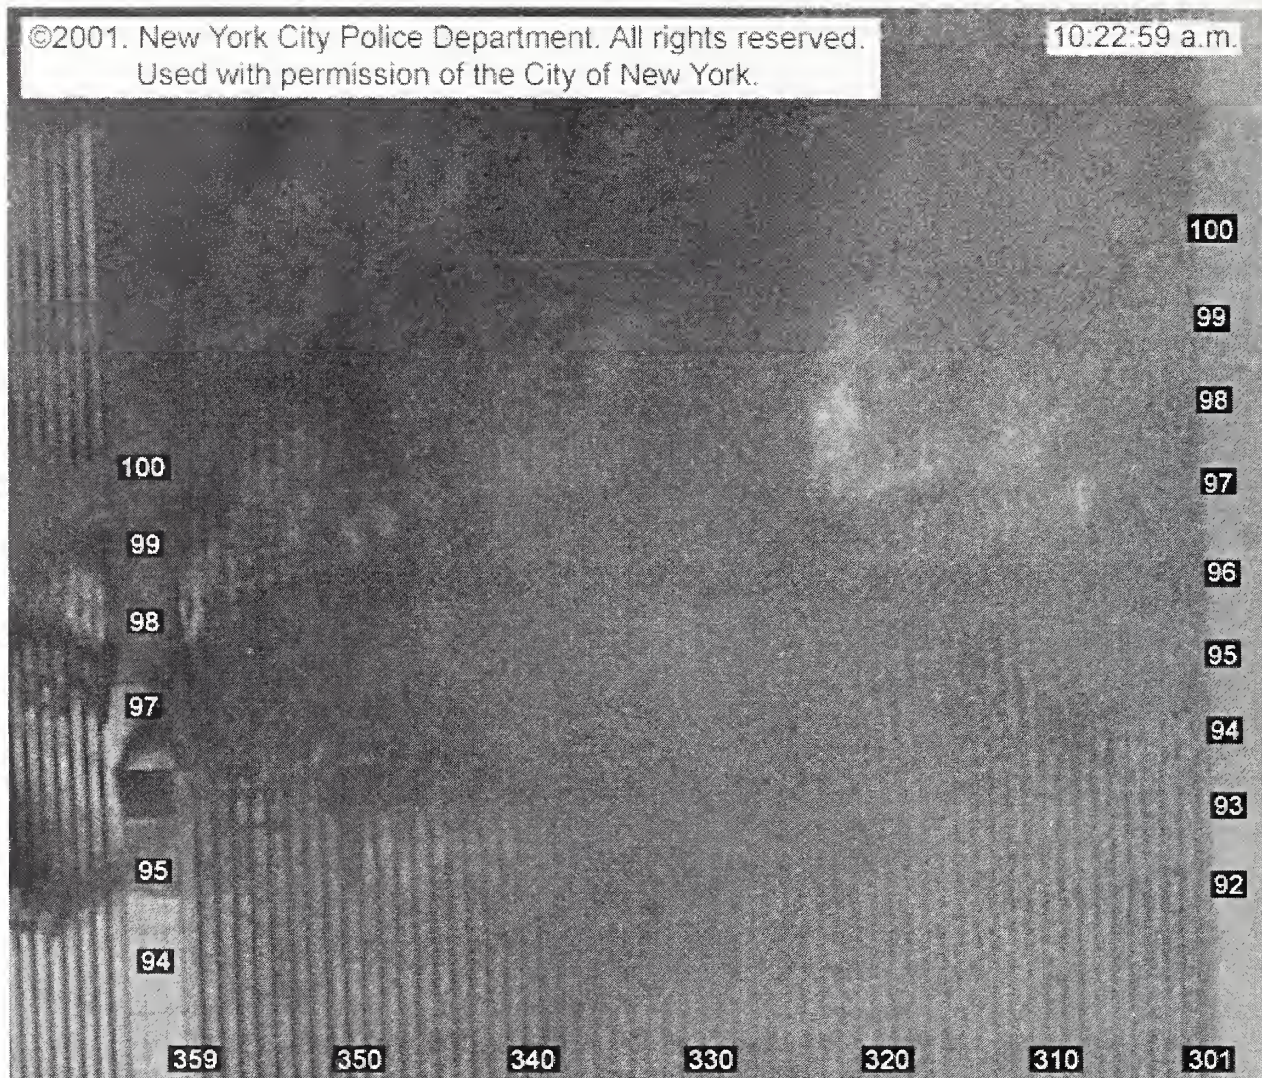
Views of the south face of WTC 1 were also limited for this time period, but several photographs taken from a helicopter flying relatively close to the tower provided a good indication of conditions on this face roughly half way through the period. Figure E-9 shows a cropped view of one of these photographs shot from the southwest at 10:22:59 a.m. Fires are visible on the east side of the face on the 92nd through 98th floors. A long distance video showed that the particularly intense fire on the 98th floor moved into the area around 10:19 a.m. Closer inspection reveals that many of the columns on the south face in the vicinity of 95th floor to the 98th floors were bowed inward at this time. Somewhat smaller flames are visible on the west side of the face on the 92nd, 96th, 98th, 99th, and 100th floors. Around 10:25 a.m. heavy smoke and fire appeared from windows in a room located in the southwest corner of the 94th floor. Long distance videos show that during the period leading up to the tower collapse the line of fire on the 98th floor continued to burn vigorously. The fire on the 99th floor appeared to intensify and move toward the east, eventually reaching a location more than half way between the center of the face and the east edge. When WTC 1 began to collapse, a large amount of flame was pushed from openings on the south face, with flames appearing to come from three separate locations. The first was from the vicinity of the intense fire burning on the east sides of the 98th and 99th floors, the second was from the fire burning on the western edge of the 94th floor, and the third came from around the center of the face near the 94th floor.

Figure E-9. This photograph showing the south face of WTC 1 is a cropped version of a photograph shot from a helicopter at 10:22:59 a.m. It has been enhanced by adjusting the intensity levels, and column and floor numbers have been added.

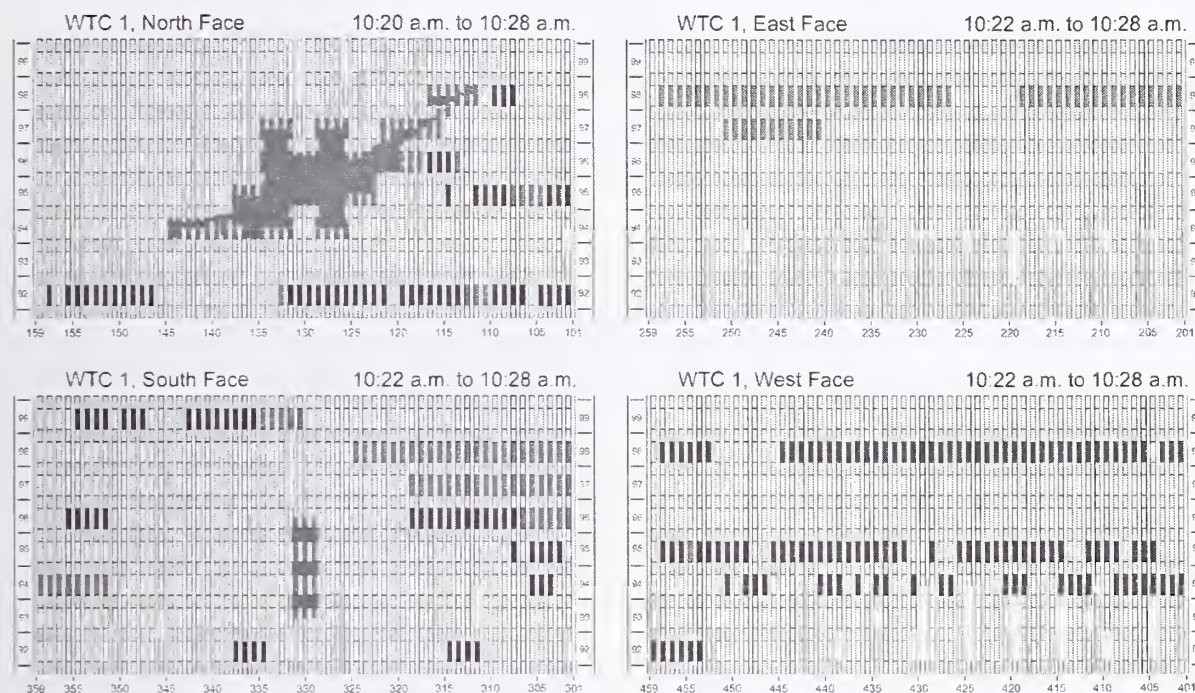
The integrated fire data for the period are shown in Figure E–10. A notable feature is the widespread presence of intense fire in the southeast quadrant of the tower following a long period when the area seemed to be isolated from fires burning elsewhere.

Figure E–10. Maps of integrated fire observations between 10:20 a.m. and 10:28 a.m. are shown for the four faces of WTC 1.

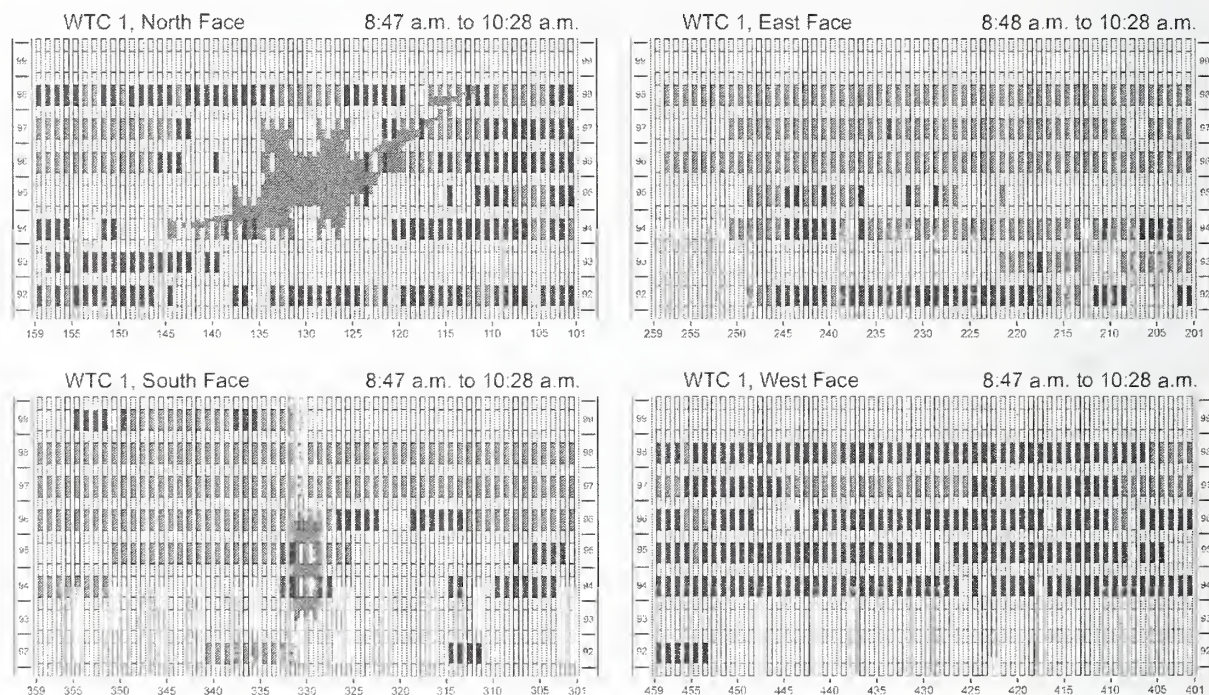
An interesting aspect of the fire behavior in WTC 1 was the variation in burning behavior observed on the different faces. Fires at most locations on the west and north faces of the towers burned without flame extension or release of large amounts of smoke from nearby windows. In many cases the fires appeared to burn as relatively low intensity distributed flames. The preponderance of red in the north and west face maps in Figure E–11 reflects this type of burning. In contrast, the fires burning on the east and south faces

most often generated external flames and heavy smoke flows at nearby windows as indicated by the extensive areas of orange on the façade fire maps. Various explanations for the different burning behaviors were considered. The most plausible is the effect of the prevailing wind. On September 11, the wind was striking WTC 1 from the northwest and then flowing down the north and west faces. This wind created positive pressures at the windows on these faces that tended to resist gas flows out of the tower. On the east and south faces the effect of the wind was the opposite, creating low pressure areas at the windows that tended to draw gases out of the building. The net effect of these pressure forces was a tendency for gases to flow internally on a floor, if a pathway was available, from the west and north faces to the east and south faces.

Figure E-11. Maps of integrated fire observations between 8:47 a.m. and 10:28 a.m. are shown for the four faces of WTC 1.

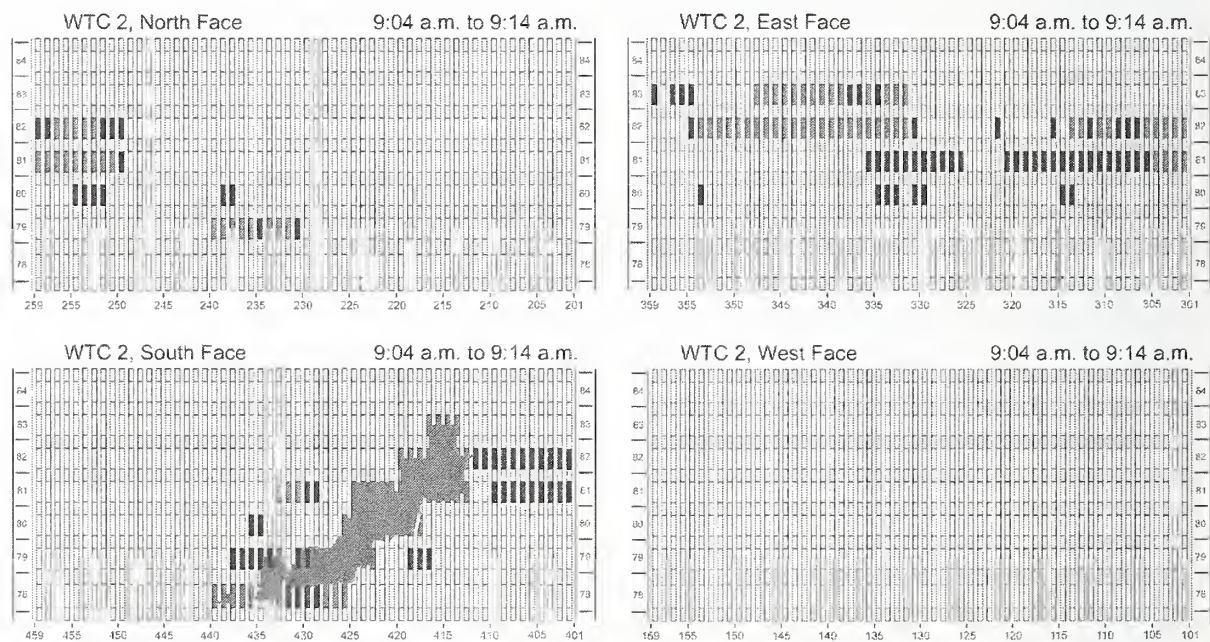
The fire data sheets for the period were integrated as a means for summarizing the fire distributions. The results are shown in Figure E-12. From these maps it is clear that the major visible fires were burning on the east and north faces of the tower. The most intense fires were on the 81st through 83rd floors, i.e., the upper portion of the floors impacted by the aircraft.

Figure E-12. Maps of integrated fire observations between 9:04 a.m. and 9:14 a.m. are shown for the four faces of WTC 2.

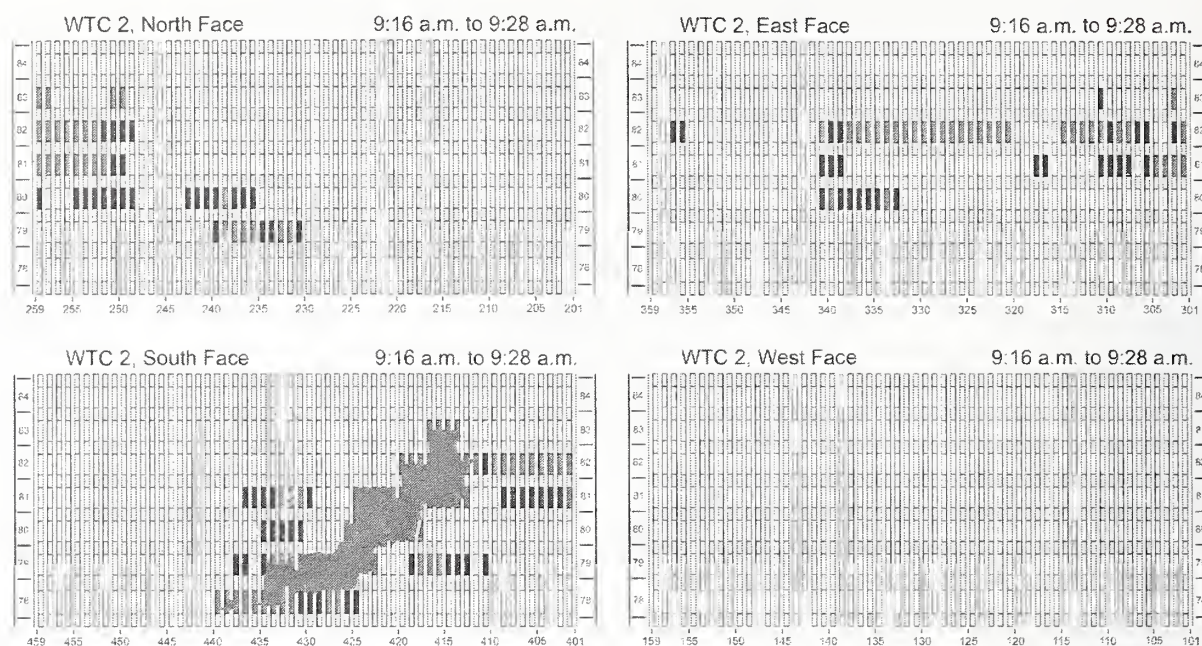
Maps of integrated fire intensities over the period for the four faces are shown in Figure E-13. Comparison with Figure E-12 confirms that minimal fire spread was taking place during the period. The fire distributions on the east face for the two periods appear quite different due to the rapid changes in the fires observed near the beginning of the first period and the continued northward spread of the fire on the 81st floor, which initially developed on the south side of the face, while going through a cycle of growth, intense burning, and decay. As during the initial time period, the largest fires were in the northeast corners of the tower on the 81st and 82nd floors and near the center of the north face on the 79th and 80th floors. These fires had been burning since the aircraft impact and were slowly dying down.

Figure E-13. Maps of integrated fire observations between 9:15 a.m. and 9:29 a.m. are shown for the four faces of WTC 2.

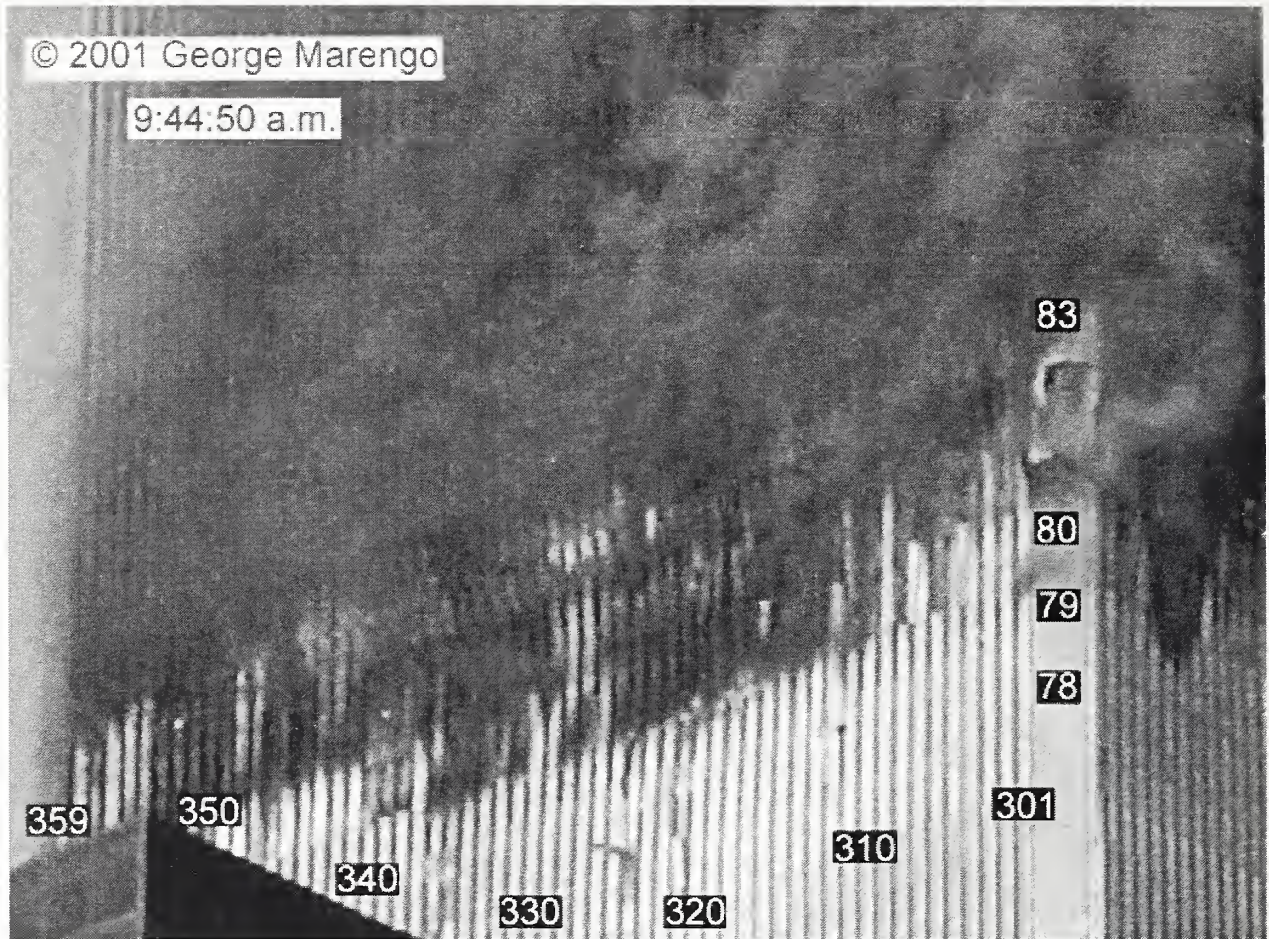
Figure E-14. This cropped photograph was shot from the northeast and shows the east face of WTC 2 at 9:44:50 a.m. The original intensity levels have been adjusted, and column and floor numbers have been added.

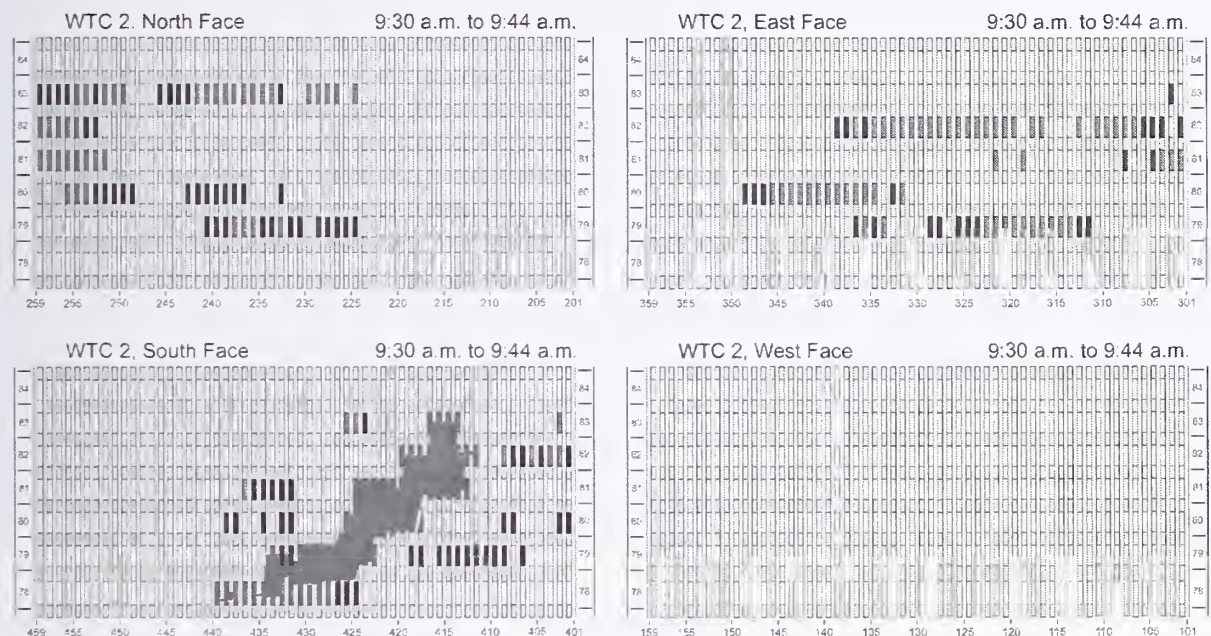
Figure E-15 shows integrated fire maps for the period. The new areas of fire that appeared on the 79th and 83rd floors of the north face are evident. Extensive new areas of fire were also present on the 79th and 80th floors of the east face. It should be remembered that a fraction of the observed fire indicated on the maps for these floors was associated with the three roughly one-minute-duration periods during which heavy smoke flows and fires were present.

Figure E-15. Maps of integrated fire observations between 9:30 a.m. and 9:45 a.m. are shown for the four faces of WTC 2.

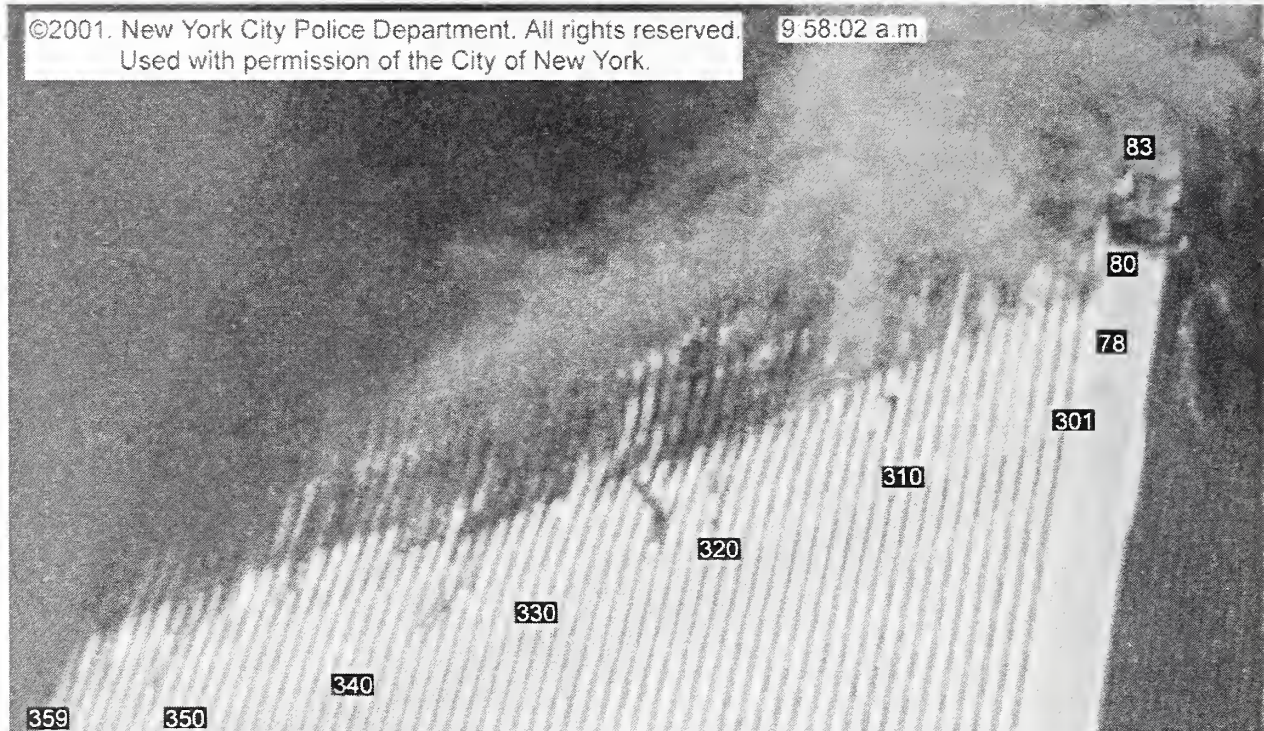
through windows on the 82nd floor changed again, with the northernmost window where the object could first be seen located slightly to the north. A prominent feature on the east face during the period was the inward bowing of the outer wall. This can be seen clearly over the 79th to 82nd floors in Figure E-16, which was taken less than a minute before the collapse started. During the 20 s prior to the collapse, a large number of pieces of debris fell from the northern sides of the 80th and 81st floors. The falling debris coincided with a heavy flow of molten metal from the north face. When WTC 2 collapsed, very little flame was expelled from the east face windows. Based on observations elsewhere on the two towers, regions of intense burning would have been expected to generate short-lived jets of flames. Their absence suggests that large fires were not burning near the east face at the time of collapse.

Figure E-16. This cropped image shows the east face of WTC 2 at 9:58:02 a.m. The intensity levels have been adjusted, and column and floor numbers have been added.

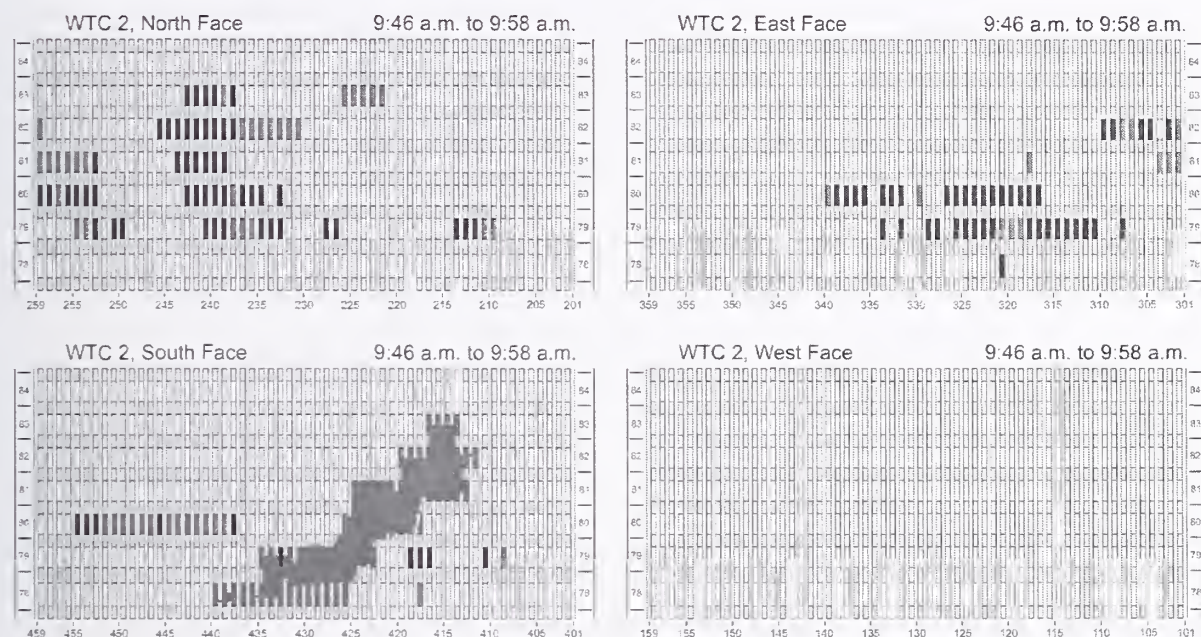
Façade maps of integrated fire intensities for the period are shown in Figure E-17. Many of the fires present during earlier periods were either no longer visible or were dying down during the final interval prior to the tower collapse. Some fire spread to the west had taken place on several floors on the north face. Areas with substantial fires included those on the north sides of the east face on the 79th and 80th floors (recall that the observed fires are combinations of sustained fires and short-lived flame releases) and the intense fire that grew on the west side of the south face on the 80th floor.

Figure E-17. Maps of integrated fire observations between 9:45 a.m. and 9:59 a.m. are shown for the four faces of WTC 2.

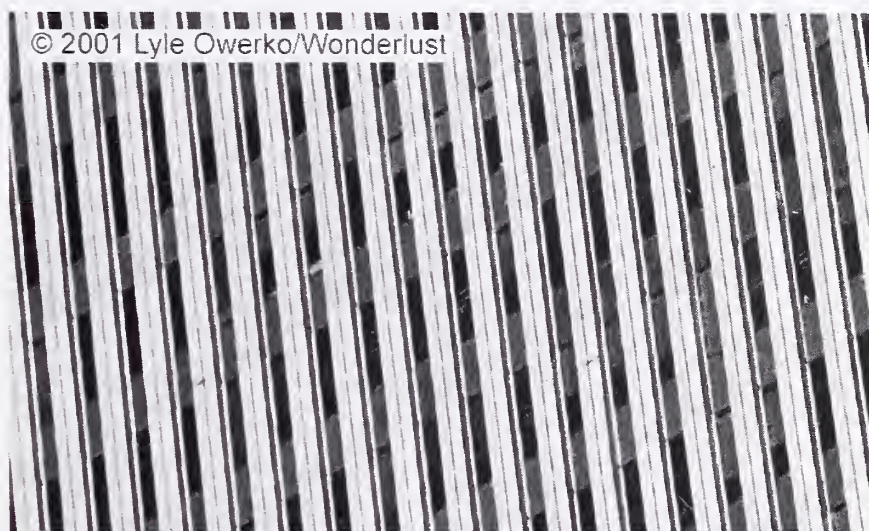
The 79th to 106th floors had the typical floor geometry, with 12 ft slab spacing and 4 ft 7 in. high spandrel covers. A view of a portion of the façade in an area on the east face of WTC 1, where the floors had the standard repeating configuration, is shown in Figure 4–7. Portions of six floors are visible. The oblique view of the image allows many of the details concerning the façade design discussed earlier to be identified. The configuration of the aluminum column and spandrel covers relative to the windows can be seen. The 1 in. wide window frames are visible, and the depth of the recessed windows relative to the column covers is clear. The expansion joints for the column covers stand out as lines running along the tops of the windows.

Figure 4-7. This cropped photograph shows an oblique view of a portion of the east face of WTC 2 in an area where the floors have the standard repeating configuration.

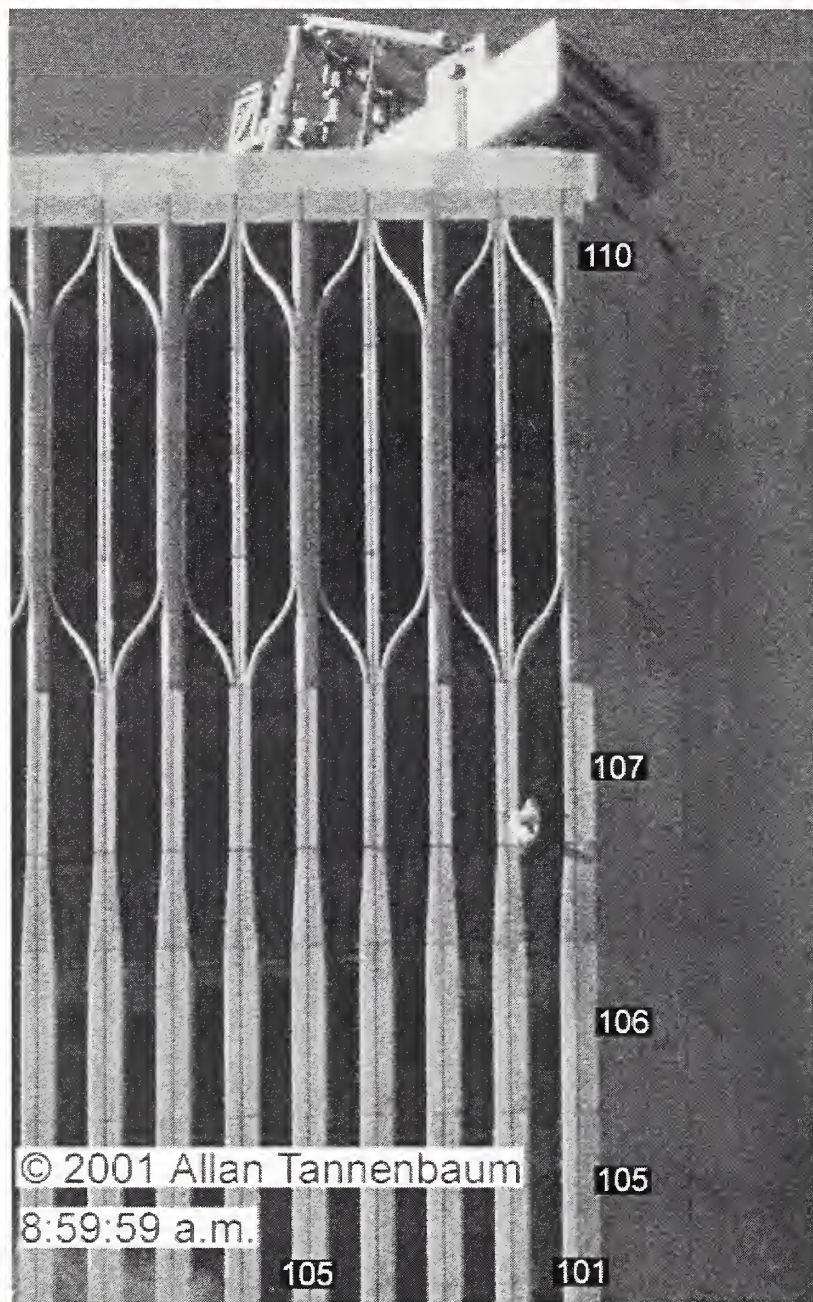
Figure 4–8 is a photograph of the upper northwest corner of WTC 1 from the 105th floor to the top of the building. The details described above are clearly seen. The large object on the top of the tower at the corner is a window washer.

Figure 4-8. This cropped photograph showing an area of the façade on the north face of WTC 1 near the top of the tower was taken at 8:59:59 a.m. A mechanical equipment room is present on the 108th and 109th floors. Column and floor numbers have been added.

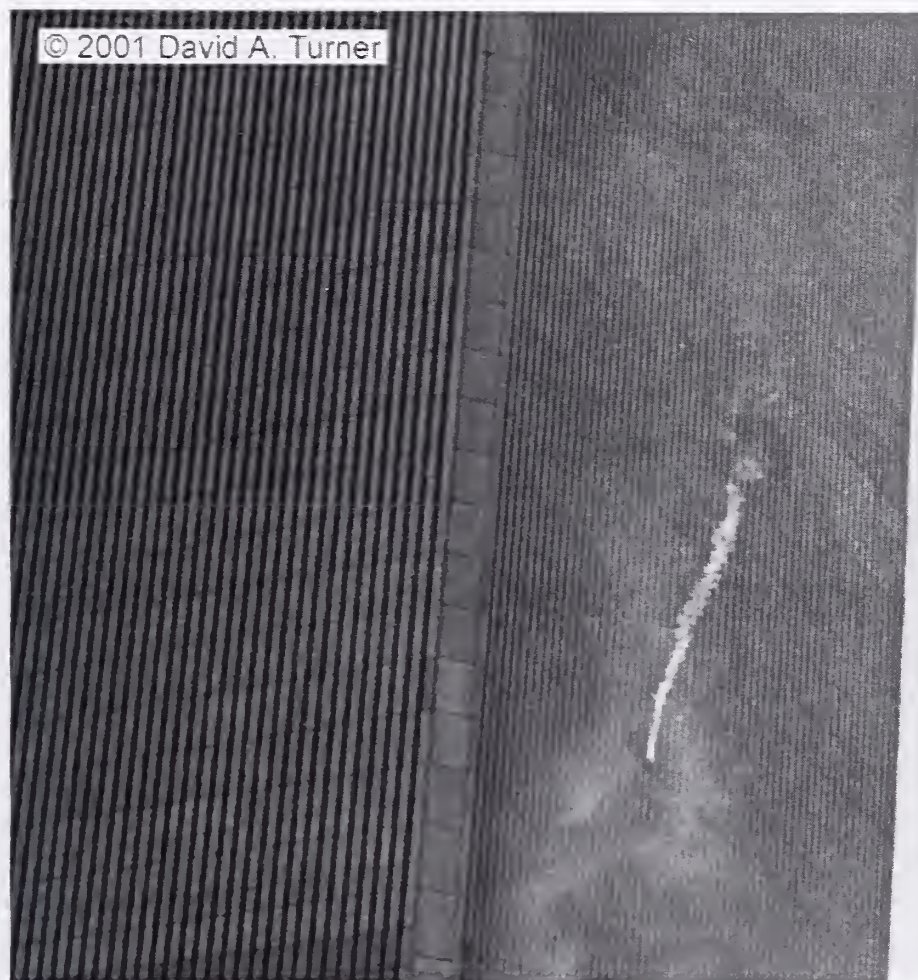
During the review of visual material, two additional behaviors were identified that seemed to correlate with the local fire intensity at the periphery of the buildings. One of these was the frequent release of “streamers” during periods of active burning. Figure 5-7 shows three streamers that fell nearly simultaneously from the south face of WTC 1. The exact time of this photograph is not known. As is clear from the photograph, when the lighting was correct, the streamers could be observed from long distances.

Figure 5-7. This cropped and enhanced photograph shows the west and south faces of WTC 1. An intense streamer is falling near the south face of the tower, and two additional streamers have already fallen through the image to the south. The exact time of this photograph is unknown.
